## Executive Summary

# Geomorphology And River Hydraulics of The Teton River

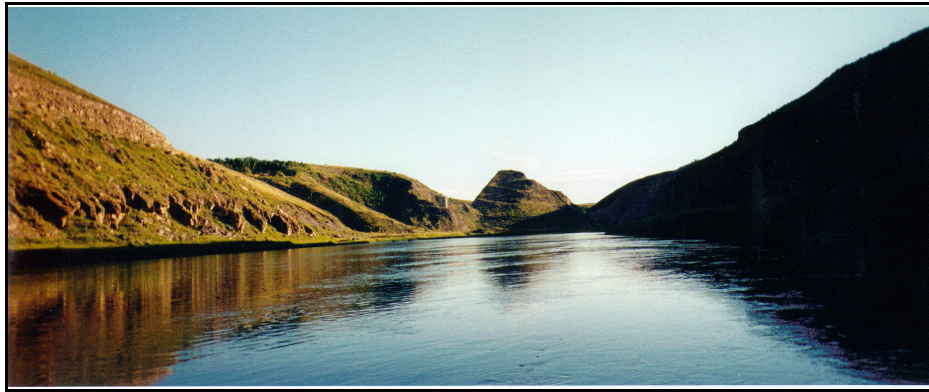
*Looking downstream at the borrow ponds and the remnants of Teton Dam.*

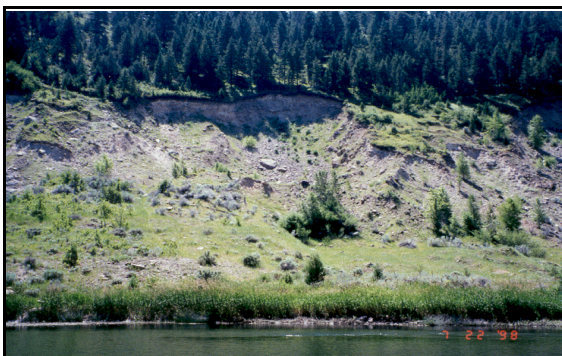
***An example of an earthflow-type slide that occurred between Spring Hollow and Canyon Creek.***

Most of the landslides were shallow surface slumps, earth flows, debris flows, and rockfall. The thickness of the landslide debris ranged from less than 5 feet to about 25 feet normal to the slope.

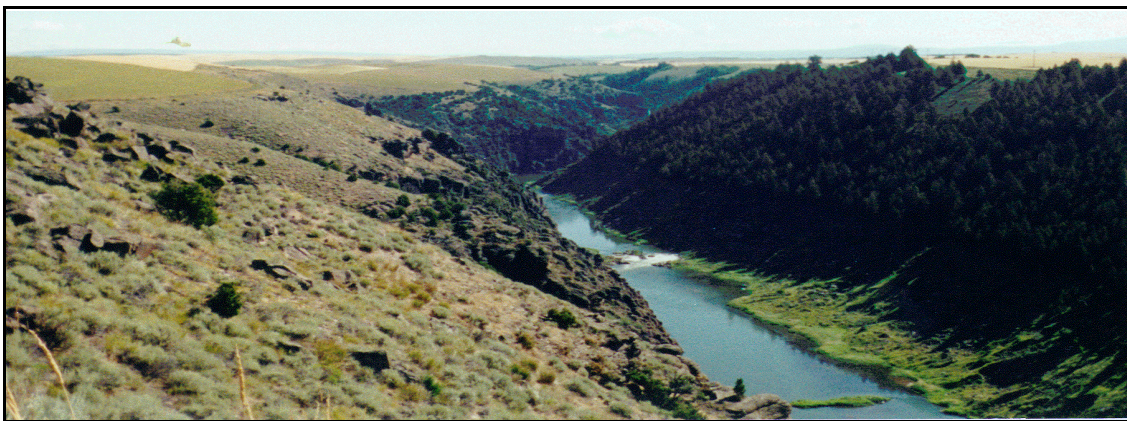
***Looking upstream (in order) at pool 12, rapid 12, and pool 11, which are all slightly downstream of Spring Hollow (rapid 9).***

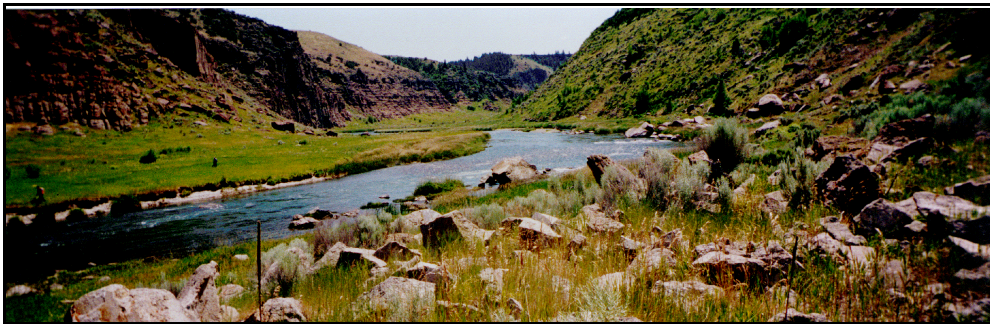
*Looking upstream at a site 4 miles upstream from the dam site, where the Teton River has wide flood plains along the north side and landslide debris along the south side.*

In the 5-mile reach downstream from the confluence with Canyon Creek to the dam site, the landslide debris associated with the filling and rapid drawdown of Teton Reservoir landed on high terraces and typically did not reach the river channel. Therefore, the river channel and its hydraulics were not significantly affected by landslides downstream from Canyon Creek.

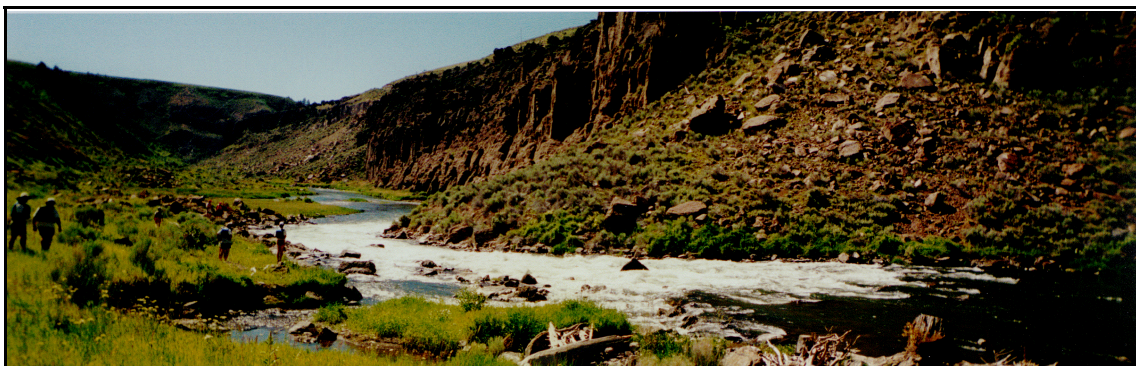
*View of Parkinson's Rapid looking downstream.*

These rapids and pools must be viewed in sequence. For example, the downstream-most rapid (informally known as Parkinson's Rapid) has the largest single drop in the river in this reach

(16 feet). The relatively short pool that was formed behind this rapid inundates much of the next rapid upstream (informally known as Little Parkinson's Rapid). If the downstream-most rapid were removed, the next rapid upstream would have an even larger drop than the drop through the existing Parkinson's Rapid.

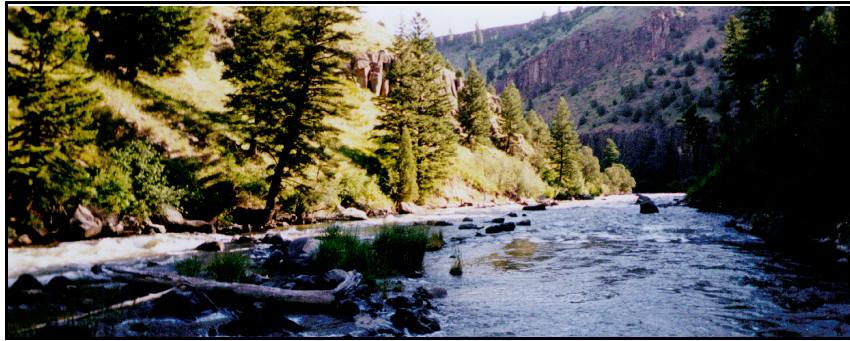
***Looking downstream from Felt Dam Powerhouse, located about 19 miles upstream from Teton Dam (upstream of the former reservoir area).***

Upstream from the former reservoir inundation area, the river channel is extremely steep and narrow. The sediment transport capacity in this reach is presumably high, as a result of the river gradient, narrow widths, and high velocities. Between Bitch Creek and pool 1 (the first pool backed up by a landslide-formed rapid), the river has shallow, uniform depths, and the channel bed primarily consists of 3-inch to 6-foot-diameter boulders.

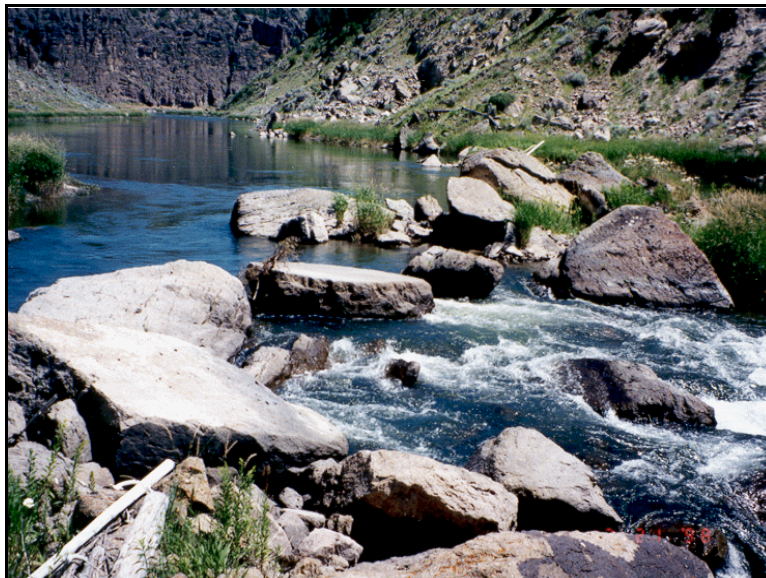
***A view of rapid 26, which was formed from landslide material that moved into the river from the north canyon wall.***

The sediment particles along the channel bottom of the pools in the Spring Hollow to Canyon Creek reach are definitely finer than the bed material downstream from Canyon Creek. Silts and clay-sized sediments have deposited along the channel bed in the longer and slower pools. The largest pools (25 and 26) were formed as a result of landslides in 1976 and occurred in a

reach (RM 5.5 to RM 6.9) where deep pools were not present in 1972. Therefore, it is likely that the bed material of these pools is much finer today (dominated by sand, silt, and clay) than it was in 1972 (likely dominated by gravel, cobble, and boulder).
